PANT PARTS & ACCESSORY NEWS TODAY

B U L L E T I N

09-07

SUBJECT: Sanding marks on select Toyota bumper covers

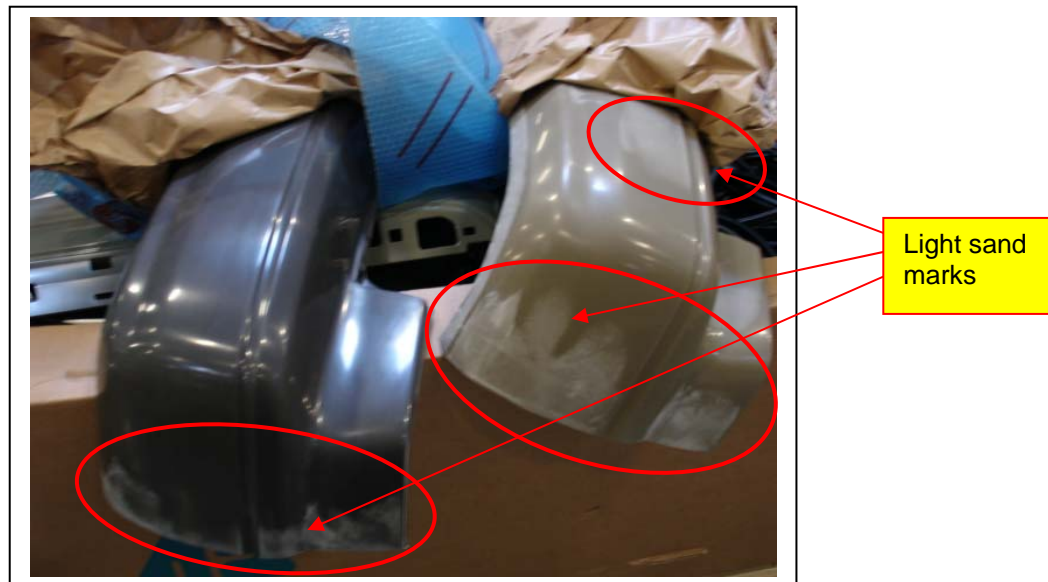
These bumper cover part numbers above may be received at your location with sanding marks on the "A" surface. These bumper covers may appear to be "used."

TMS quality group made an investigation with supplier, TEMA PBM and University of Toyota to understand impact on part quality and paint adhesion. Light surface sanding is sometimes performed at the supplier to remove surface burrs and ensure a surface that supports good paint adhesion. While the sanding marks are visible on the "A" surface, there are no issues with the sanding marks bleeding through after paint finish is applied.

TMS Body Service Group participated in part validations during the vendor trials prior to the supplier being awarded this business. They confirmed light surface sanding could be necessary to produce quality parts and would not be noticeable after priming and finish coat of paint were applied. Therefore, damage claims should not be filed due to the light sanding marks on the part surface.
